# Citizen's Guide to the Stekoa Creek Watershed Management Plan

The purpose of the *Citizen's Guide to the Stekoa Creek Watershed Management Plan* is to present information that can improve water quality in the Stekoa Creek watershed, to help sustain and improve the economic value of Rabun County's natural resources, and aid in securing the well-being of the community for generations to come.

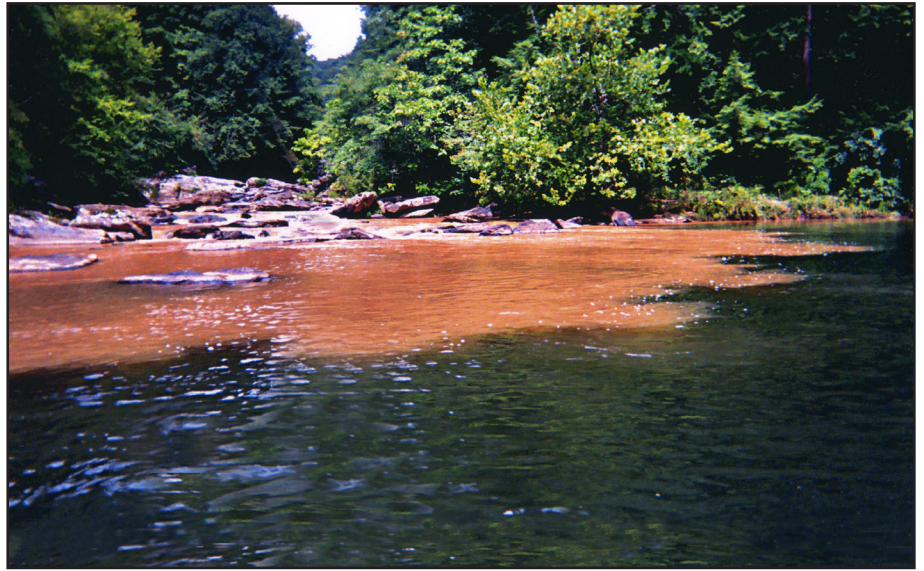
**STEKOA CREEK - CHATTOOGA RIVER CONFLUENCE**  
*Stekoa Creek is known for carrying excessive levels of sediment and/or E. coli bacteria into the Chattoga River.*
