# Lower Chattooga River Before Tugalo Dam

By David S. Leigh, Shishir Rao, and Seth J. Wenger

University of Georgia River Basin Center Scientific Investigations Report 2022-DSL-01

Submitted 15 November 2022 to American Rivers, and revised and re-submitted 11 March 2023

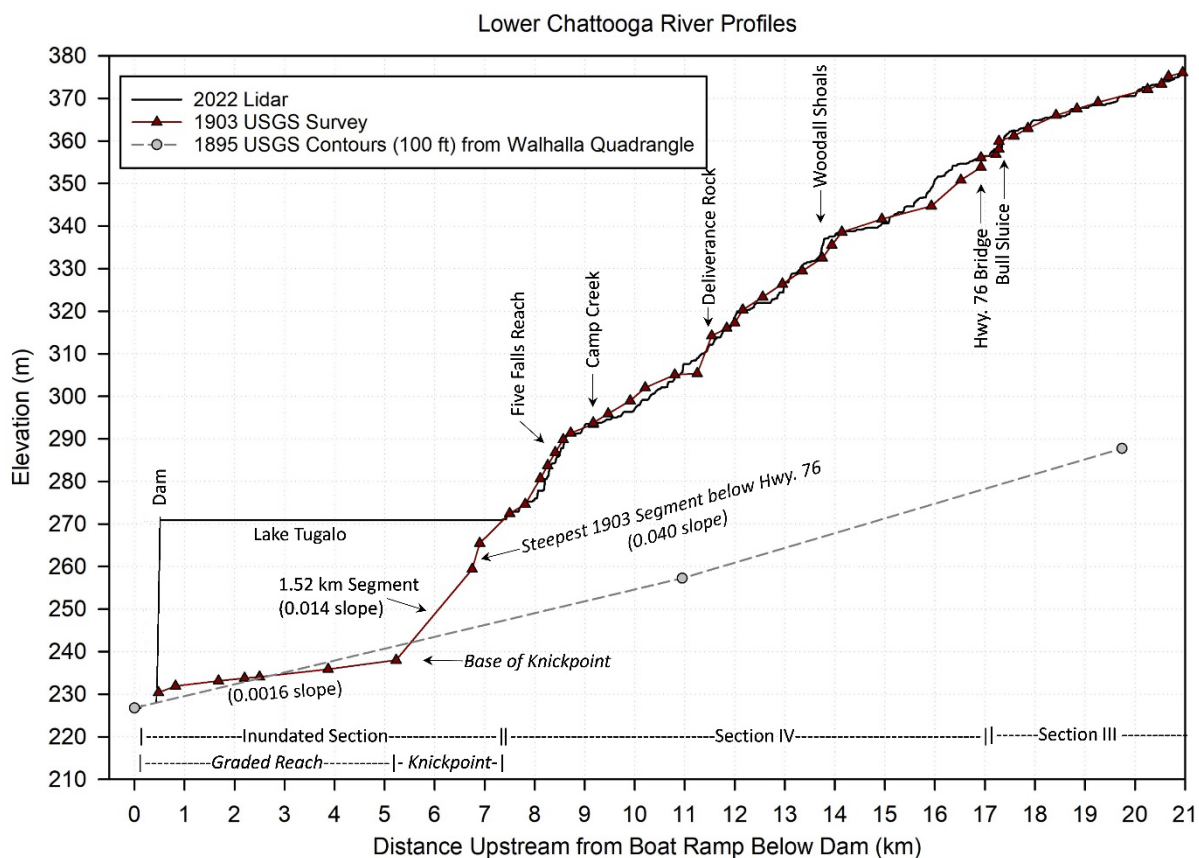
**Figure 2.** Longitudinal profiles of the Chattooga River comparing the 1895 and 1903 pre-dam surveys against the latest 2022 elevations from 1 m lidar grid cells. The zero distance is located at the concrete boat ramp at 0.5 km downstream of the top edge of the Tugalo Dam.

all of whitewater Section IV and the terminal reach of whitewater Section III of the river (Figures 1 and 2) (<https://www.americanwhitewater.org/content/River/view/river-detail/476/main>; [https://www.sherpaguides.com/georgia/mountains/blue\\_ridge/eastern/chattooga\\_river.html](https://www.sherpaguides.com/georgia/mountains/blue_ridge/eastern/chattooga_river.html)), and this free-flowing reach above Lake Tugalo is used as an analog for understanding the inundated lowest reach beneath the lake. This is one of the highest gradient portions of the main stem of the Chattooga River profile. This portion exhibits a convex longitudinal profile (Figure 2), which is characteristic of steep erosional knickzones and knickpoints adjusting to the lower base level imposed by the ancient stream capture. It contains many class III-IV-V whitewater cascades interspersed with class I-II rapids, riffles, glides, and pools. Most of the high-gradient cascades and rapids are bedrock reaches with rock sills and ledges, along with numerous potholes etched into the rock.

The unusually steep segment of the 1903 survey from the bottom of the 1.52 km segment up to the top of the Five Falls reach (Figure 2) is befitting of the overall longitudinal morphology of the river, because this coincides with the knickpoint segment of steep channel gradients adjusting to lower base levels imposed by the ancient stream capture event. That is, knickpoint erosion typically migrates “headward” (in the upstream direction) from the point of capture as the channel adjusts its gradient to the new base level conditions (Figure 6) as a “graded” stream. The relatively low gradient from the dam upstream to the base of the 1.52 km segment is the new “graded” reach that has been eroded by the river as the knickpoint moved upstream through time. Indeed, the slope of the lower 5 km (0.0016) is very similar to the slope of the Tugaloo River below Yonah Dam (0.0015), confirming that the Chattooga River is graded to the main stem of the Tugaloo River. Thus, the base of the knickpoint at 2 km downstream

from the upper end of the lake (Figure 2), marks significant transition from the steep upper reach to the gentle lower reach of the inundated channel. Despite the lack of survey points within the steep 1.52 km segment, the point at the base of that segment appears to be a good

Given the steep slope conditions of the upper 2 km of the inundated knickpoint reach (Figure 2), it is reasonable to conclude that its morphology would be very similar to the steep Five Falls reach (Figure 9). That is, having a steep average gradient of about 0.015, a bankfull width of about 30-50 m, very steep (0.03-0.10) class IV and V cascades over bedrock separated by lower gradient segments with boulder-cobble riffles and glides. Rock-fall boulders would commonly occur within the reach as a result of the relatively narrow gorge, and “youthful” rock outcrops with potholes would be common. Fine sediment (sand and silt) would fill spaces

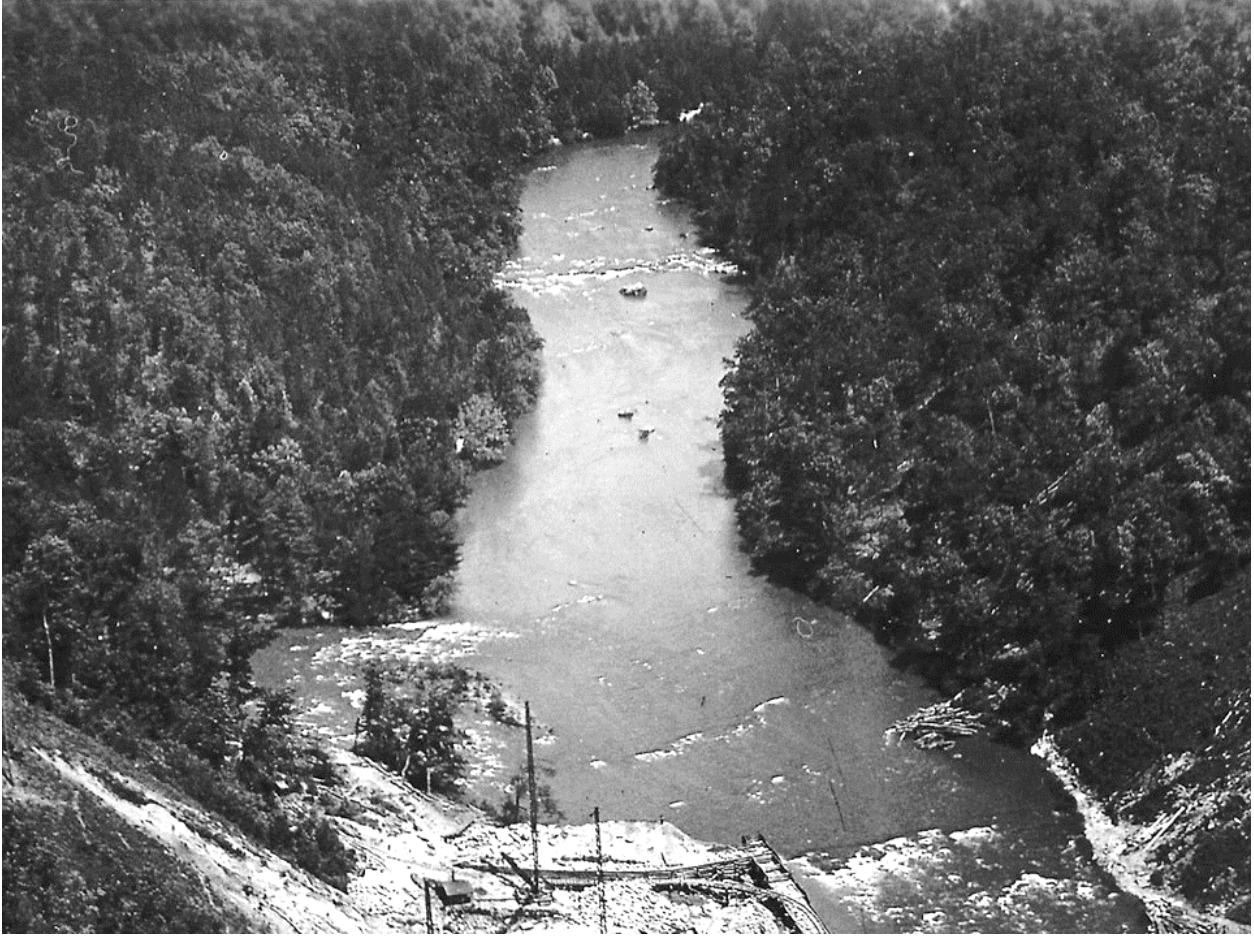
**Figure 4.** Oblique aerial photo of the mouth of the Chattooga River in 1922. Photo courtesy of Georgia Power Company as posted on the Chattooga Conservancy website (<https://chattoogariver.org/initiatives/restore-chattooga-gorge/>).

The 1922 oblique aerial photos looking northward from the dam construction site do show a slight eastward meander bend (Figures 3 and 4), and that bend appears to be about 0.4 to 0.5 km upstream of the confluence with the Tallulah River. This is too short of a distance from the dam for the bend to correspond to a bend in the bedrock gorge, so it probably does indicate minor free meandering of the river channel, or “wandering” at least in its lowest kilometer. Also, a small portion of floodplain surface (or a low terrace) is visible on the north side of the river bend in the 1922 photos, indicating ample alluvium for a wandering reach of the river. If the river is wandering in that lowest kilometer, where the gorge is relatively narrow and straight, then it also probably was wandering further upstream where the gorge is definitely wider immediately downstream of Worse and Bad Creeks. Thus, it is probable that there were some wandering segments of the river below the knickpoint, where sinuosity may have reached values of 1.3-1.4 within the wider portions of the alluvial bottomland. However, it still would not be considered a true “meandering river”, as that designation requires sinuosity of at least 1.5.

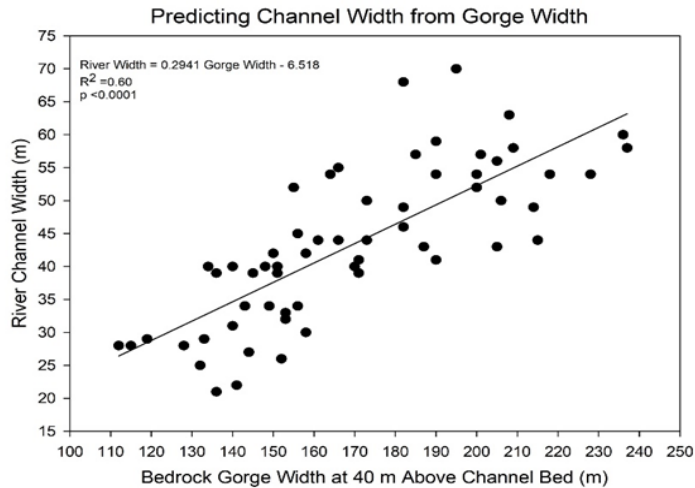
**Figure 7.** Bivariate plot of measured gorge width at 40 m above the channel bed versus measured river channel width.

The analog model relating bedrock gorge width to channel width from Section IV and the lowest part of Section III (Figure 7) shows a highly significant statistical relationship ( $R^2 = 0.60$ ,  $p < 0.0001$ ). Channel width within the Chattooga gorge is not simply a positive function of contributing drainage area, as assumed by standard hydraulic geometry relationships. In fact, the data show that the average width of the Chattooga River actually *decreases* slightly with downstream direction (Figure 8), opposite to what hydraulic geometry would predict. Thus, the bedrock gorge is exerting influence on the channel width, probably by constricting the channel in the more durable rocks that form the narrower gorges and by rock-fall boulders from the steep gorge slopes that impinge upon and constrict the river channel. At the upper end of the inundated reach beneath Lake Tugalo, the bedrock gorge begins a gradual widening in the

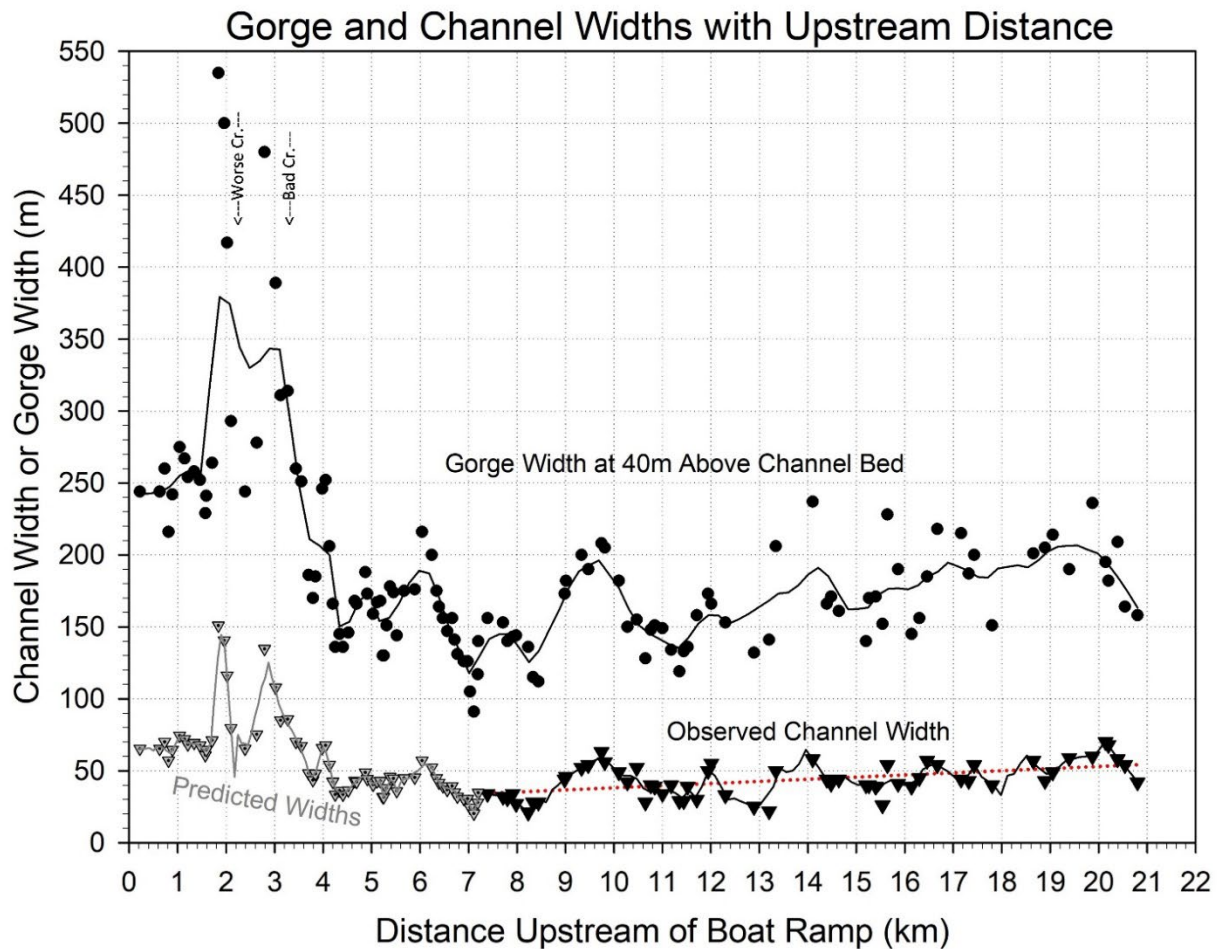
**Figure 8.** Plot of river channel width (bottom triangles) and gorge width (circles) at 40 m above the channel bed. A LOESS smoothing curve (trend line through points) was applied to each data set using a 0.075 sample interval and a first-order polynomial. The red dotted line is the linear regression showing that the average channel width actually decreases with distance downstream. The zero distance is located at the concrete boat ramp at 0.50 km downstream of the top edge of the Tugalo Dam at the southern end of the Tugalo Campground next to the river. Therefore, subtract 0.5 km to derive distance above the dam.

downstream direction (Figure 8), and the gorge widths predict the channel widths near the mouth to be 60-70 m, which closely agrees with the 1922 photos.

The middle section of the present-day lake includes some wide fluctuations in the gorge widths that correspond to pronounced widening in the vicinity of the mouths of Worse Creek and Bad Creek (Figure 8), except that there is a long isthmus that causes a short stretch of narrowing immediately upstream of Worse Creek (Figures 1 and 8). Thus, there probably was some proportional narrowing and widening of the river channel as a function of changes in gorge width. In fact, the 1922 oblique aerial photograph illustrates some narrowing of the channel immediately upstream of a subtle constriction occurring where boulders have accumulated in the channel (Figures 3 and 4). The regression model of gorge widths (Figure 7) predicts that the channel might have been 100-150 m wide within the wide valleys in the vicinity of Worse Creek and Bad Creek mouths (Figure 8); however, those predictions probably are incorrect, because they are extrapolated well beyond the empirical observations, and in those areas of the wide gorge it is more likely that there was an alluvial channel, rather than a bedrock channel, which is where the 52-53 m wide channel width predicted by the hydraulic geometry is more likely. Unfortunately, no modern analogs exist for alluvial reaches of the channel in the Section IV reach upstream of the lake, but comparable size rivers in the region (Chattahoochee, Tuckasegee, Pigeon) commonly show narrower reaches of channels with alluvial beds versus and wider channels in the bedrock reaches (Table 1).

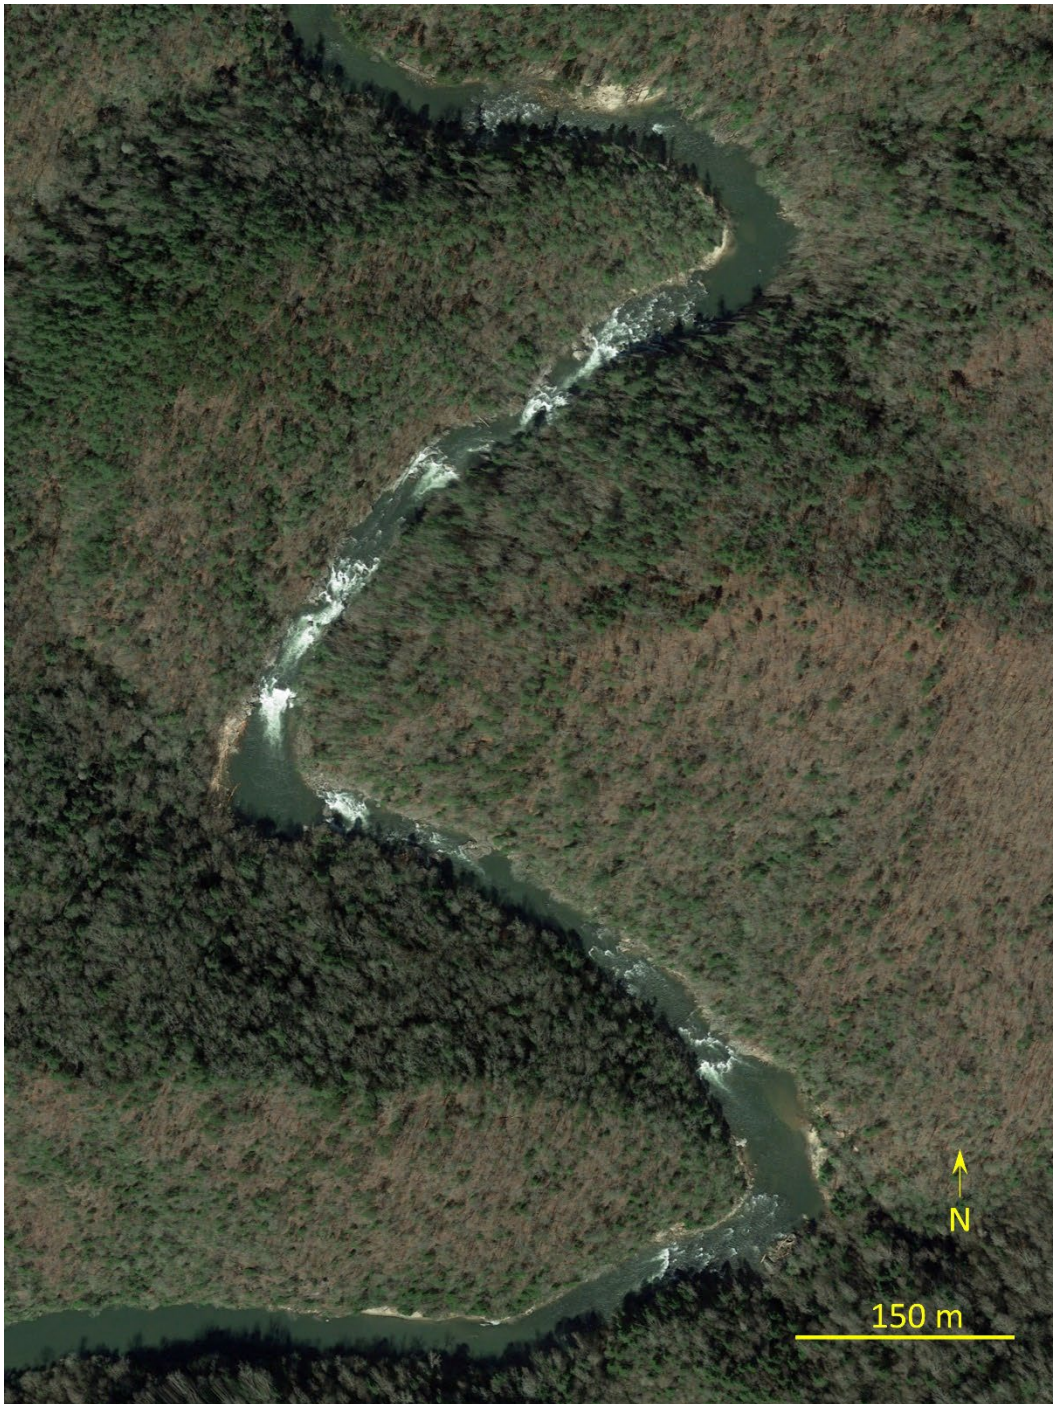
**Figure 9.** March 16, 2019 aerial image (from Google Earth) of the Five Falls reach of the Chattooga River immediately above Lake Tugalo. The channel beneath the uppermost 2 km of the lake, the knickpoint reach, probably resembled this prior to 1923.

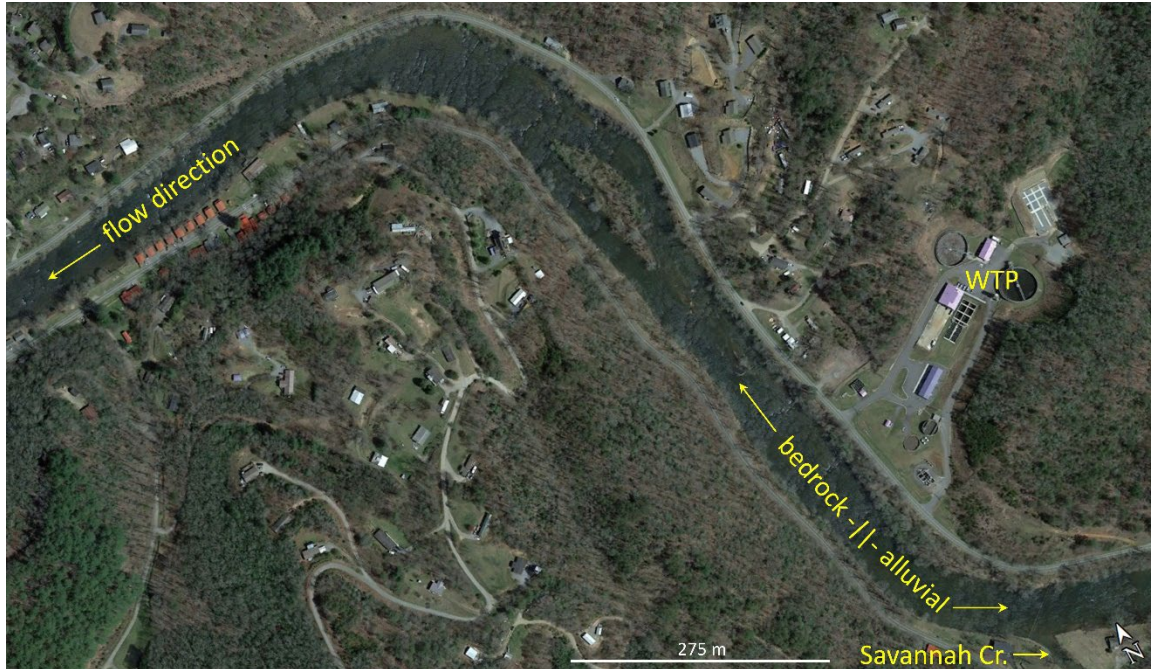
**Figure 10.** Aerial image (April 2022 from Google Earth) of the Tuckasegee River just below its confluence with Savannah Creek, and just upstream of Dillsboro, North Carolina near the water treatment plant (WTP). The stream gradient in this reach is 0.0018 and watershed area upstream is 738 km<sup>2</sup>, which is very similar to the lower 5 km reach of the inundated Chattooga River. The alluvial reach just above the water treatment plant is narrower than most of the bedrock reach.

The best regional analog of the three rivers mentioned (Table 1) for the lower 5 km of the inundated Chattooga River is the Tuckasegee River between its confluence with Savannah Creek and Dillsboro, North Carolina next to the water treatment plant (Figures 10 and 11). This river reach shows a combination of both bedrock and alluvial stretches over a short distance. Here the river cuts through a small gorge on the southwestern flanks of Kings Mountain with a 60-80 m wide bedrock channel, and bedrock shoals reveal transverse beds of resistant rock outcrops; in addition, there is a short alluvial reach immediately downstream of the Savannah Creek confluence (Figure 10), which is only 50-60 m wide. This analogous reach of the Tuckasegee River drains a comparable 738 km<sup>2</sup> and it has a very similar gradient (0.0018) to the lower 5 km of the inundated Chattooga River (0.0016).

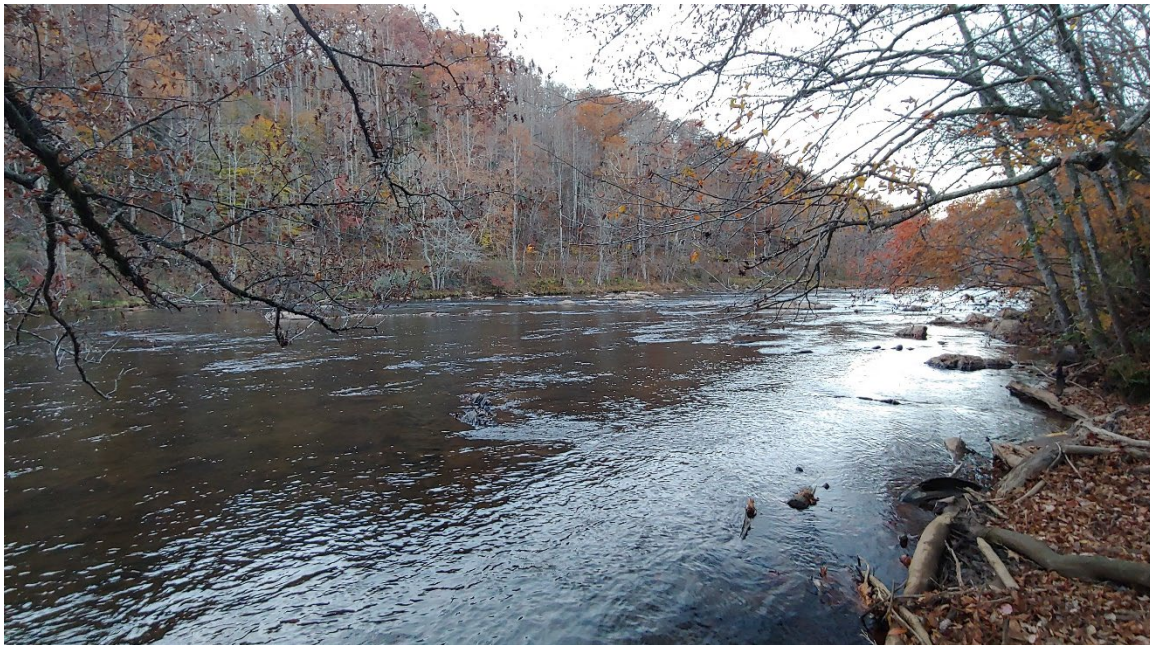
**Figure 11.** Ground view of the Tuckasegee River at the water treatment plant just upstream of Dillsboro, NC, looking downstream (photographed by David S. Leigh on 27 October 2022). This is a good analog of what the lowest 5 km of the Chattooga River probably looked like prior to 1923.

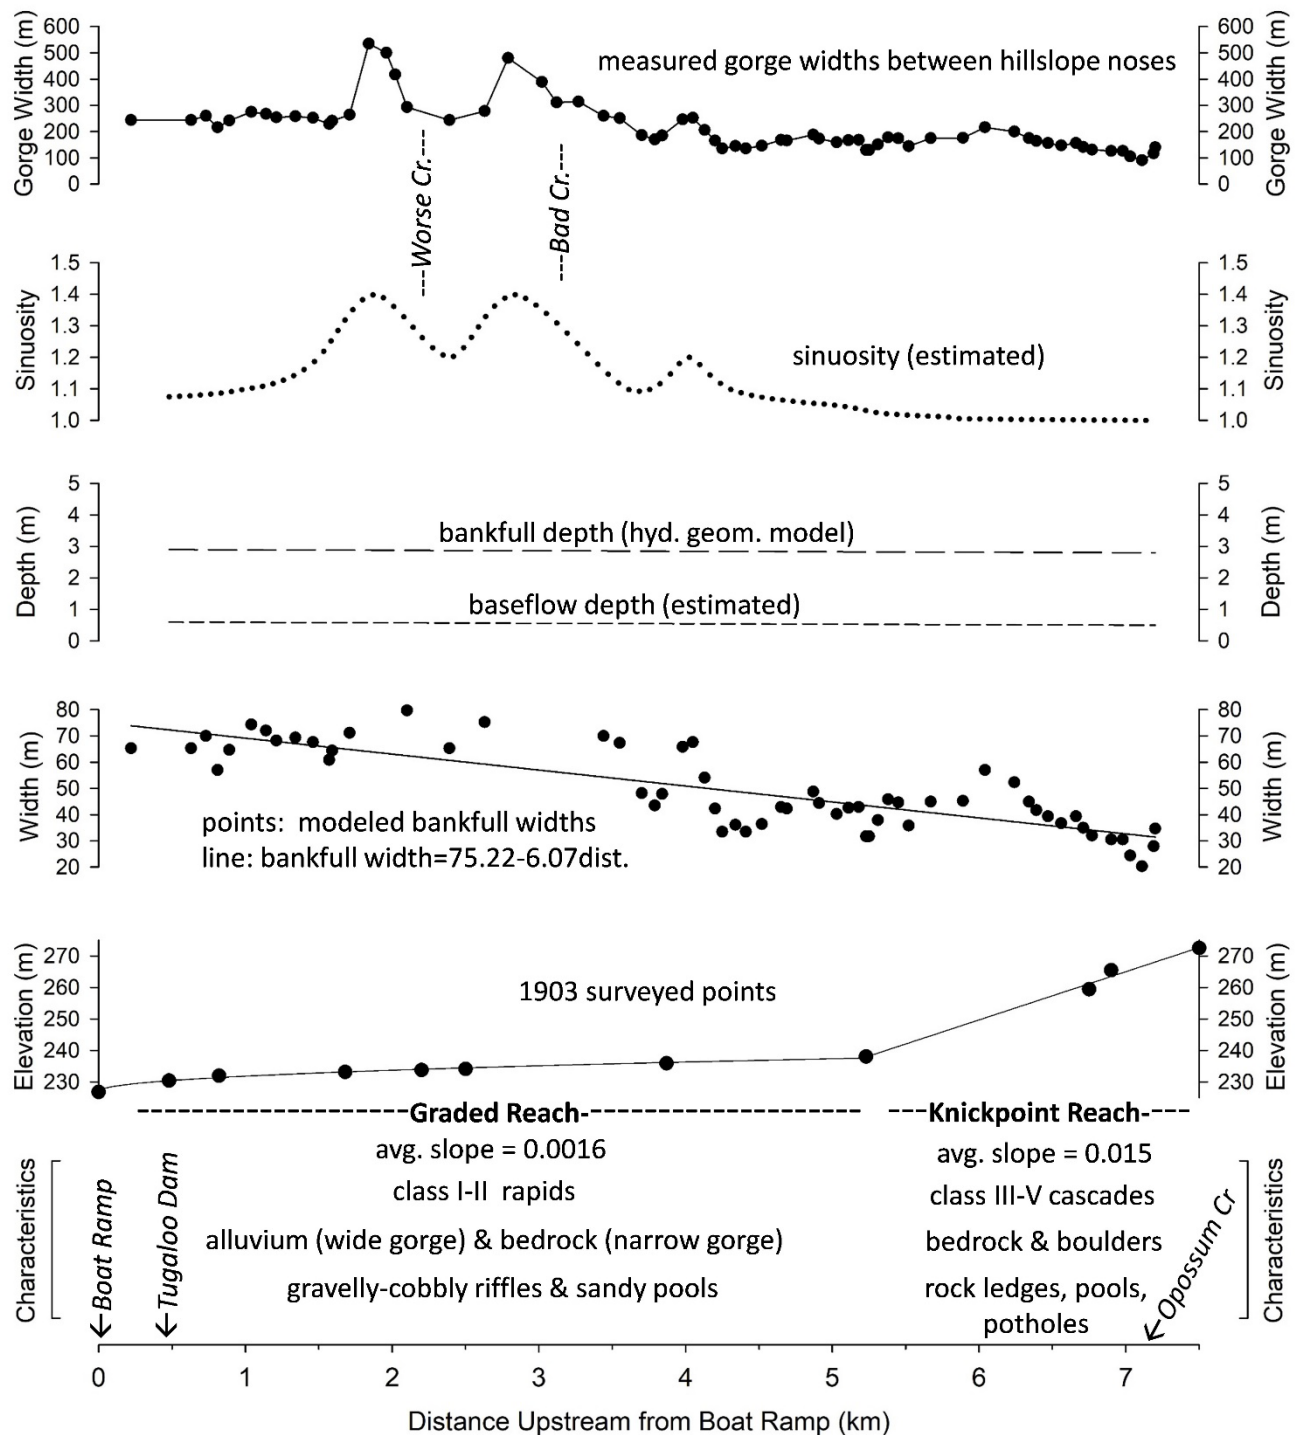
**Figure 12.** Graphic summary of Chattooga River morphology beneath Lake Tugalo. Gorge widths were measured from hillslope noses on either side of the valley at 40 m above the 1903 river channel. Sinuosity is an estimate for the channel in alluvial valleys, not sinuosity of the bedrock gorge. Bankfull depths were calculated from hydraulic geometry models (Appendix C). Channel widths are predicted from gorge widths (see Figure 7). The 1903 survey points are from Hall and Hall (1908) with distances adjusted to the boat ramp (zero point) and elevations adjusted to the 2022 LiDAR DEM.

The inundated river channel beneath Lake Tugalo would have had two distinctly different reaches prior to 1923, which we refer to as the *knickpoint reach* and the *graded reach*. These two sections are logical byproducts of long-term river channel adjustment following the ancient capture of the Chattooga River system into the Tugaloo system from its original Chattahoochee course. The likely morphologies of the two reaches are described below and summarized in Table 2 and Figure 12.
