# Chauga River Watershed Planning

Project intro, status, & timeline  
+ public input opportunity

Chattooga Conservancy

March 2026

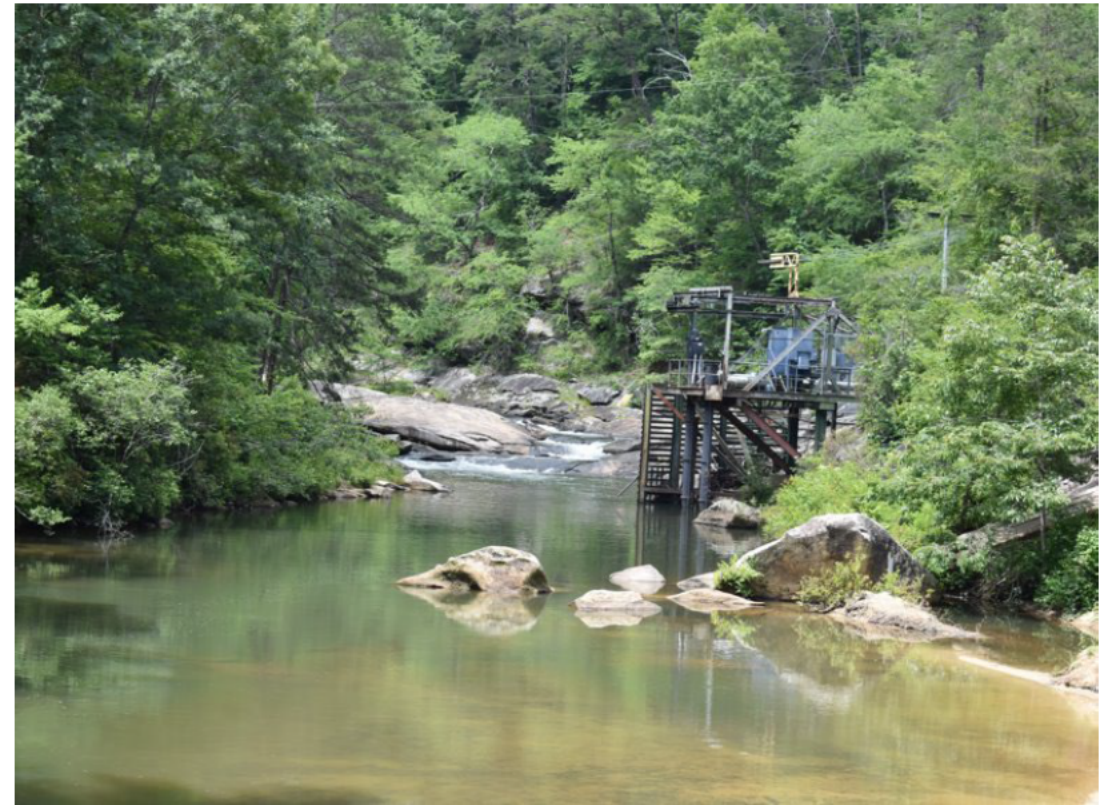
City of Westminster water intake, Chau Ram County Park. Photo: Steven Pruitt

- **Drinking water:** The City of Westminster surface water intake is in Chau Ram County Park in the Lower Chauga watershed. This utility provides drinking water to approximately 7,500 residents.
- **Recreation:** Much of the watershed (~43%) is public land in the Sumter National Forest. The river and its surrounding national forest are valued recreational resources for fishing, hiking, swimming, hunting, camping, etc. for residents and visitors alike.
- **Biology:** The Chauga is one of the state's few cold-water mountain rivers. It supports many unique biological communities, such as the Chauga Crayfish (listed as "imperiled" by SC DNR), Bartram's Bass, and trout species (both stocked and wild).

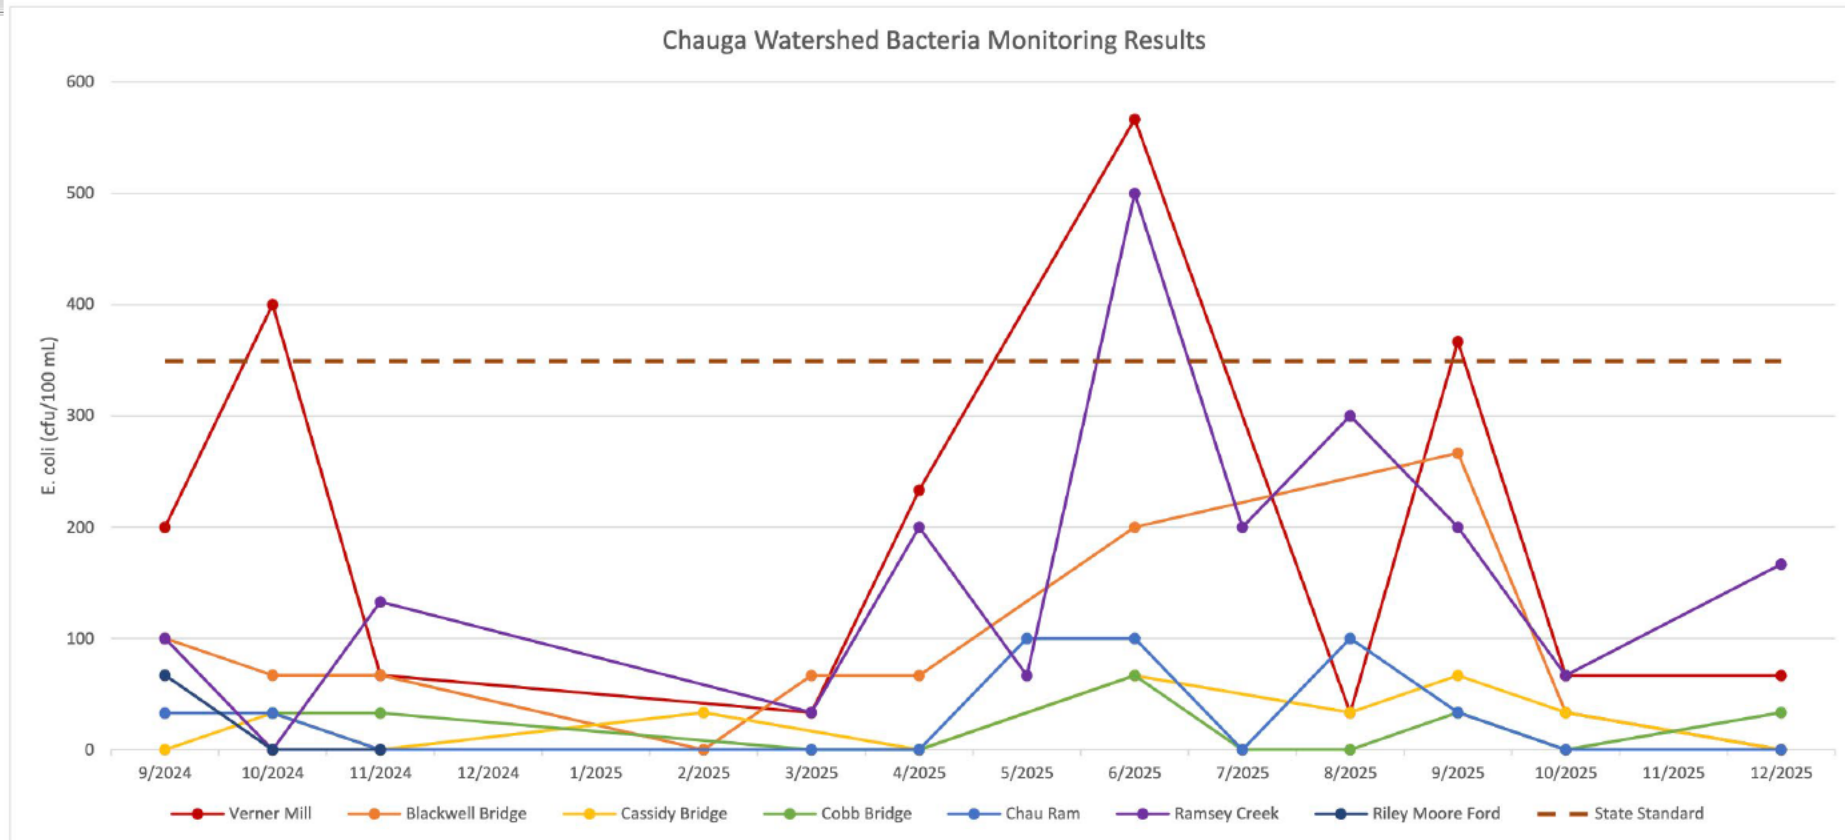
# Water quality data: **bacteria**

## Chattooga Conservancy, 2024-2025

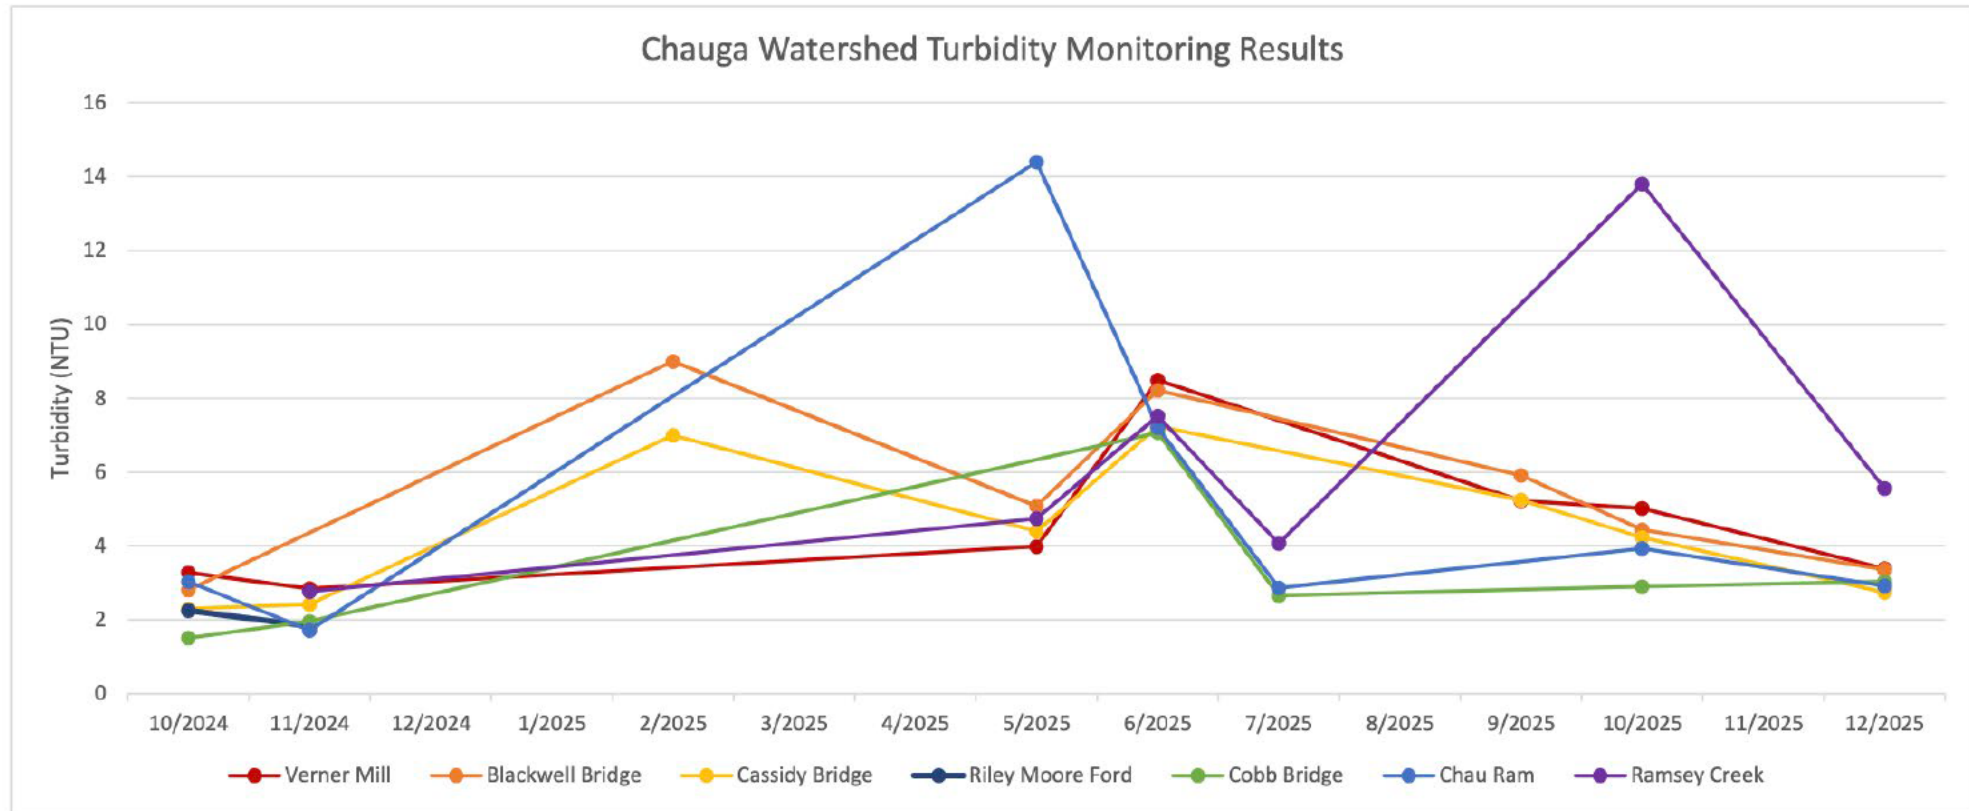
# Water quality data: **turbidity**

## Chattooga Conservancy, 2024-2025

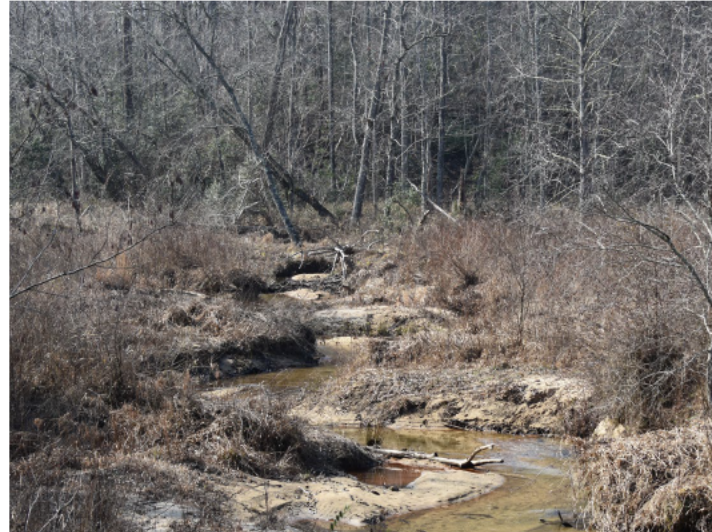
Streambank erosion on an Upper Chauga tributary. *Photo: Steven Pruitt*

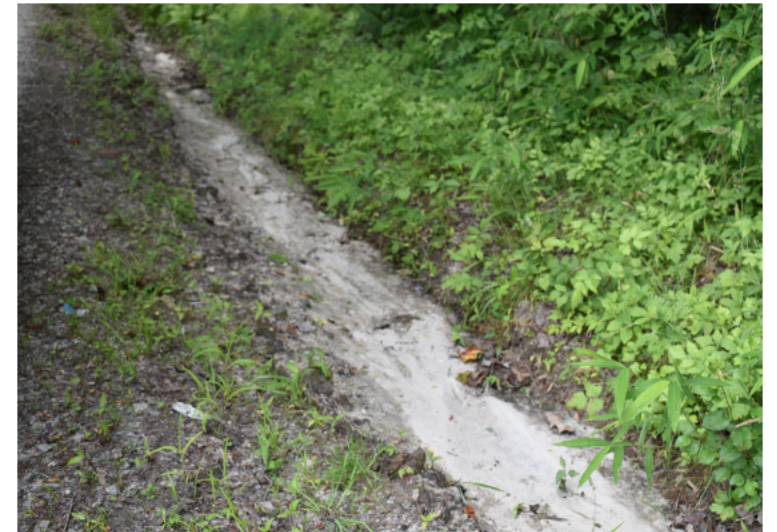
Sediment infilling a roadside ditch in the Upper Chauga watershed. *Photo: Steven Pruitt*

- Elevated bacteria levels at first Chauga River monitoring site
- Tributaries with historically documented high sediment concentrations include East Village, Village, Taylor, and Jerry Creeks (Brewer, 1998)
- Sedimentation in ditches along gravel roads adjacent to/draining to streams

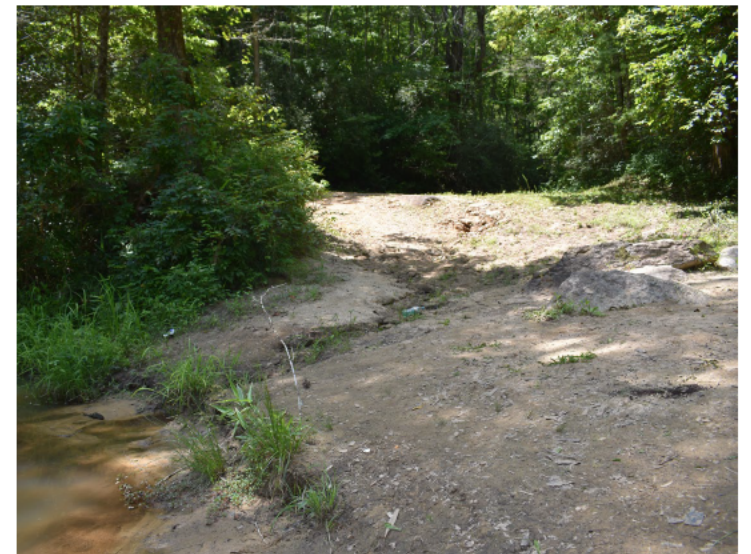
Erosion/rutting channels sediment into the Chauga River from gravel/dirt roads.  
*Photo: Steven Pruitt*

Observed potential pollution sources include eroded streambanks, road stormwater runoff, litter, vehicle tracks near streambanks, etc.

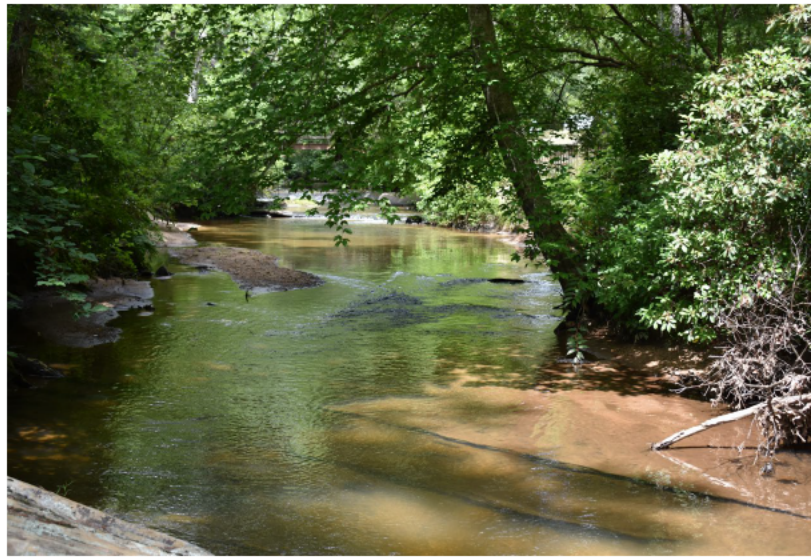
Sediment in Ramsey Creek at the Chauga confluence.  
*Photo: Steven Pruitt*

- Historical sediment concerns in Rocky Fork and Ramsey Creek (Brewer, 1998)
- Elevated bacteria levels measured in Ramsey Creek in recent monitoring
- Non-native invasive species on streambanks
- Recent Hwy 76 bridge repair and removal of historic bridge

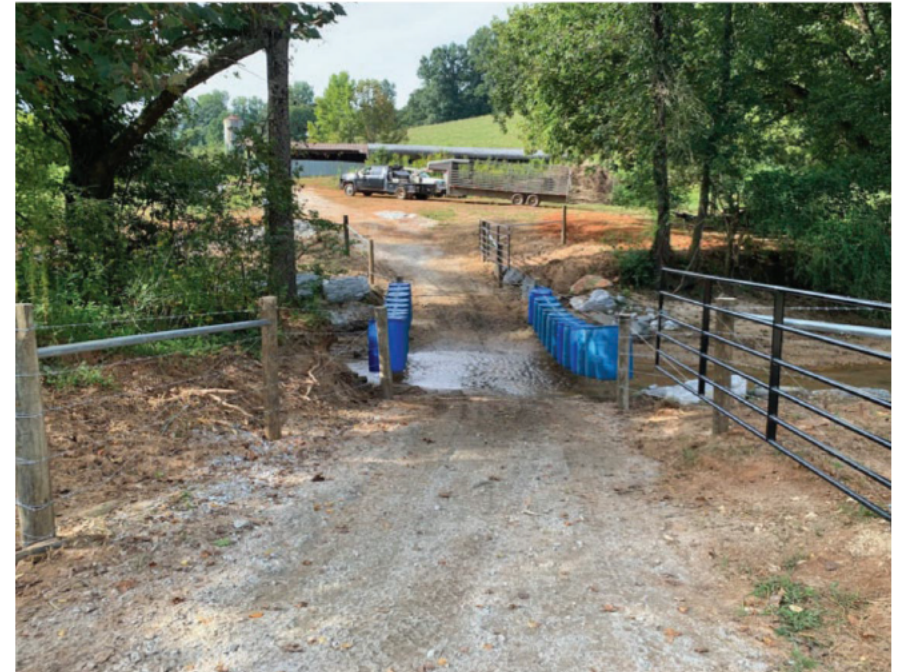
Cattle exclusion fencing in the Saluda River watershed.  
Photo c/o Save Our Saluda

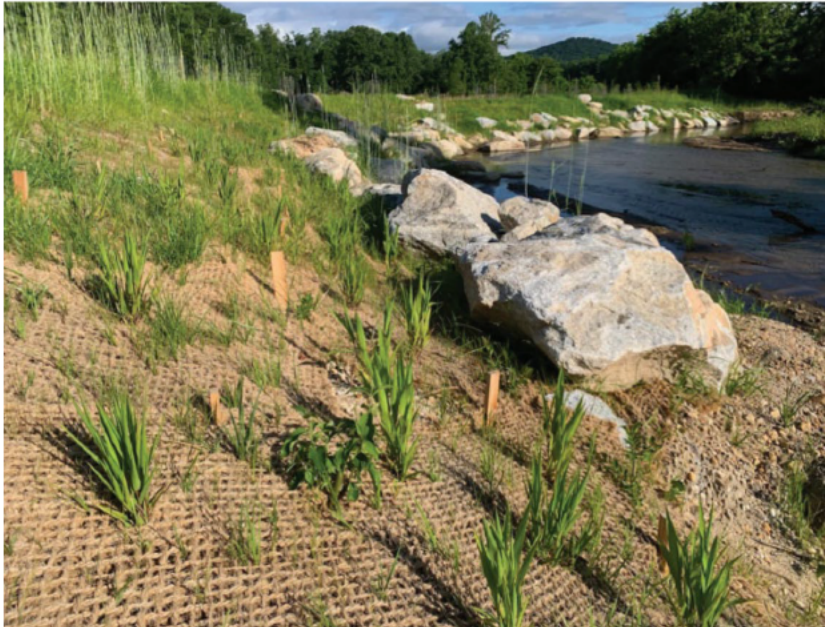
Riparian buffer restoration on agricultural land.  
*Photo c/o Save Our Saluda*

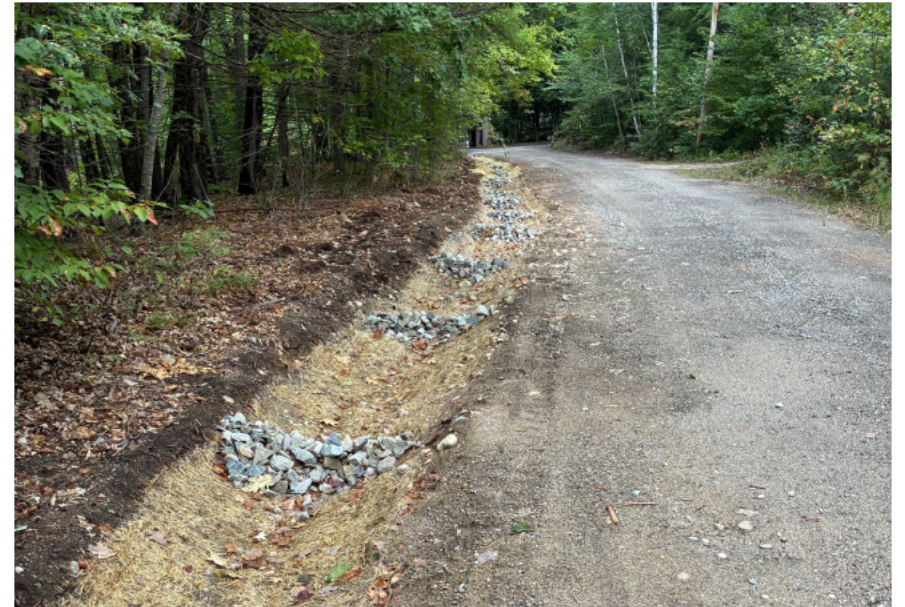
Roadside swale revegetation with rock check dams for sediment and erosion control.

*Stormwater runoff from roads, particularly gravel and dirt roads, has the potential to deposit significant volumes of sediment and other pollutants into streams. Strategic road design and regular maintenance can measurably reduce these inputs.*
